Manhole Inspection Summary

Manhole # S25CC_025MH

Insp Date: **7/19/07 10:38 AM**

Location Address: **1017 SMITHSON ST**

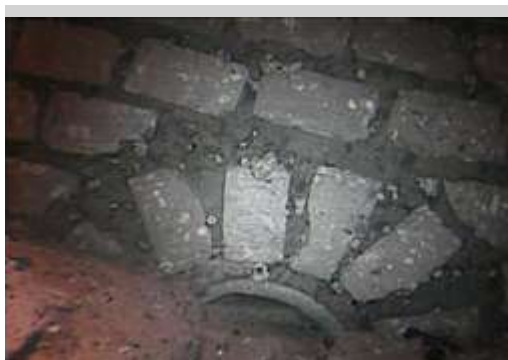
abandoned pipe at i4

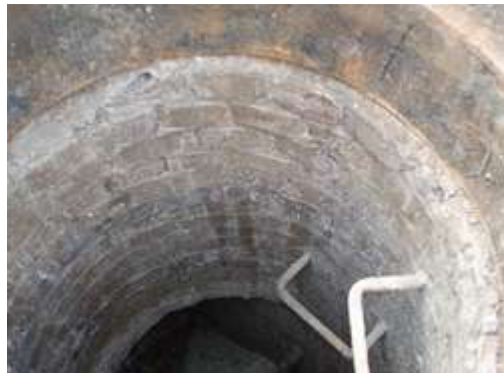
Defect 2

Infiltration: ☐ None ☐ Joint ☐ Cracks ☐ Mortar ☐ Roots ☒ **Wall**

INFILTRATION OF CORBEL WALL

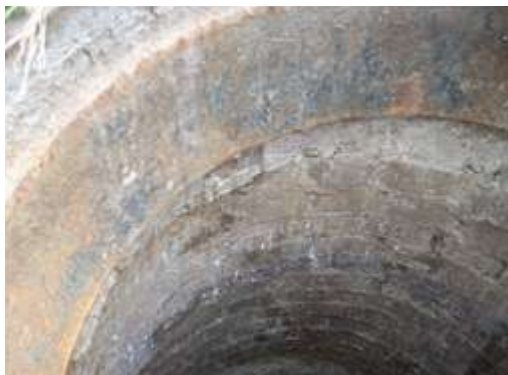
Defect 4

Condition: ☐ Sound ☐ Cracked ☐ Root Intrusion ☐ Loose Brick ☒ **Deteriorated**

DETERIORATED CORBEL

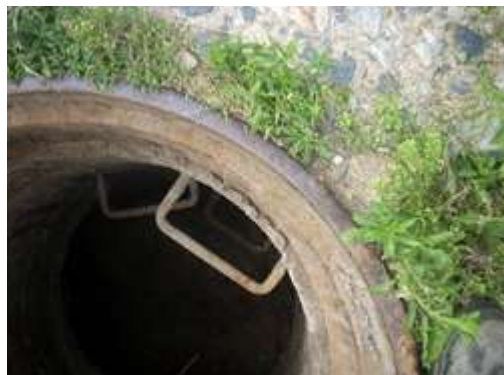
Defect 1

Frame Offset: **1** (in.) Condition: ☒ Sound ☐ Cracked ☐ Leaks

FRAME OFFSET

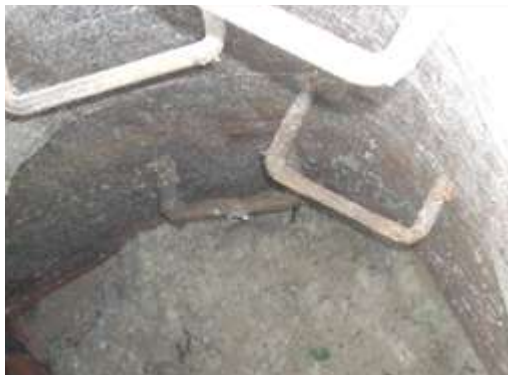
Defect 3

Steps Count: **5** Missing: **0** ☒ **Corroded**

CORRODED STEPS
